Subject: XPR Torch Heads Change

Effective February 3, 2023, a change to our XPR[®] torches was implemented to improve reliability of the electrical connection between the electrode and the cathode inside the torch head.

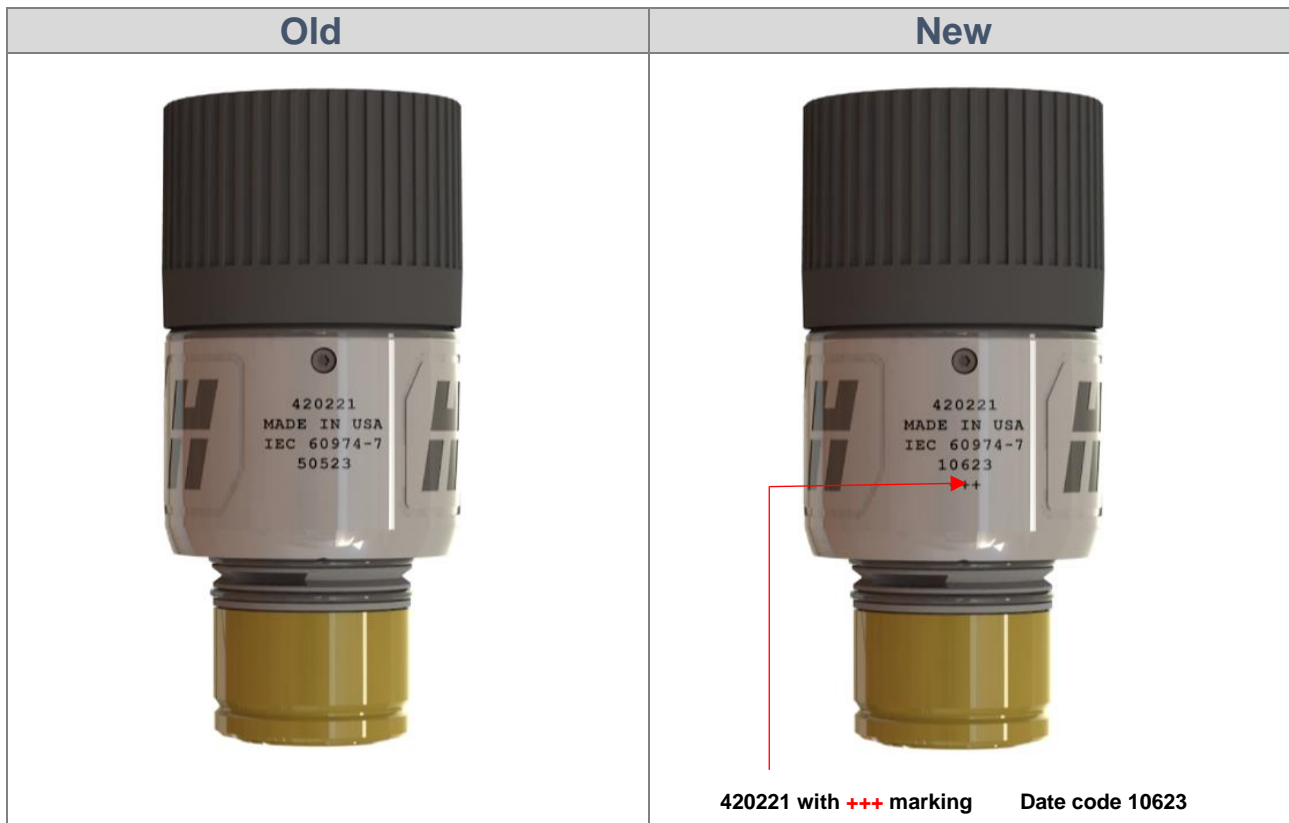
The change addresses torch life issues produced by a loose electrode condition and involved an internal modification in the torch (not visible to the operator) and the new electrode design that we announced and implemented in December 2022.

- New XPR torch heads include a differentiated mark “+++ “, making it easier to identify the updated design in the field. See below:

- There is no need to inspect/clear inventory, change plasma cutting process/part programs or proactively change out XPR torches or electrodes as the design is completely backwards compatible and the failure mode is somewhat site specific. Not all sites experienced torch life issues caused by the loose electrode.

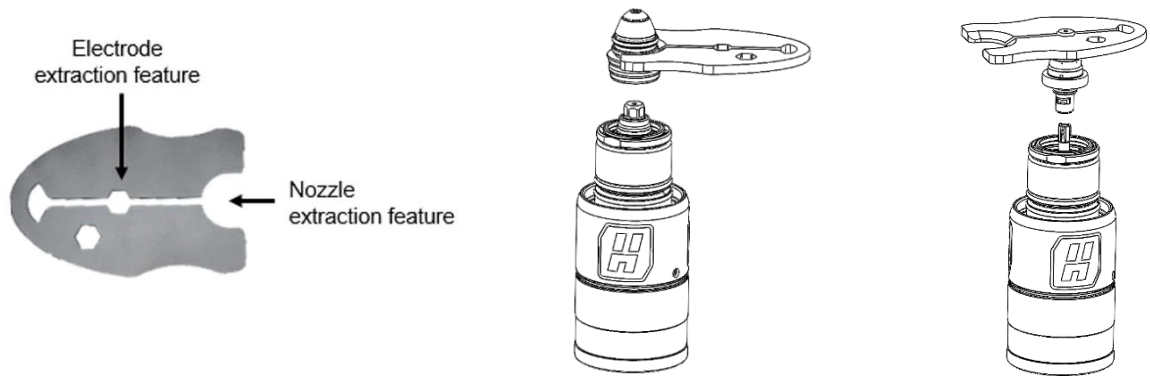
Reminder: The XPR electrode change was implemented in December 2022

Old	New

<p>420240 (example)</p>

<p>420240 (example) - Date code 15122</p>
